INDUSTRIAL MANUFACTURING TECHNICAL REPORT

Automotive Industry: Rapid and Precise Surface Inspection on Hard-to-Image Samples

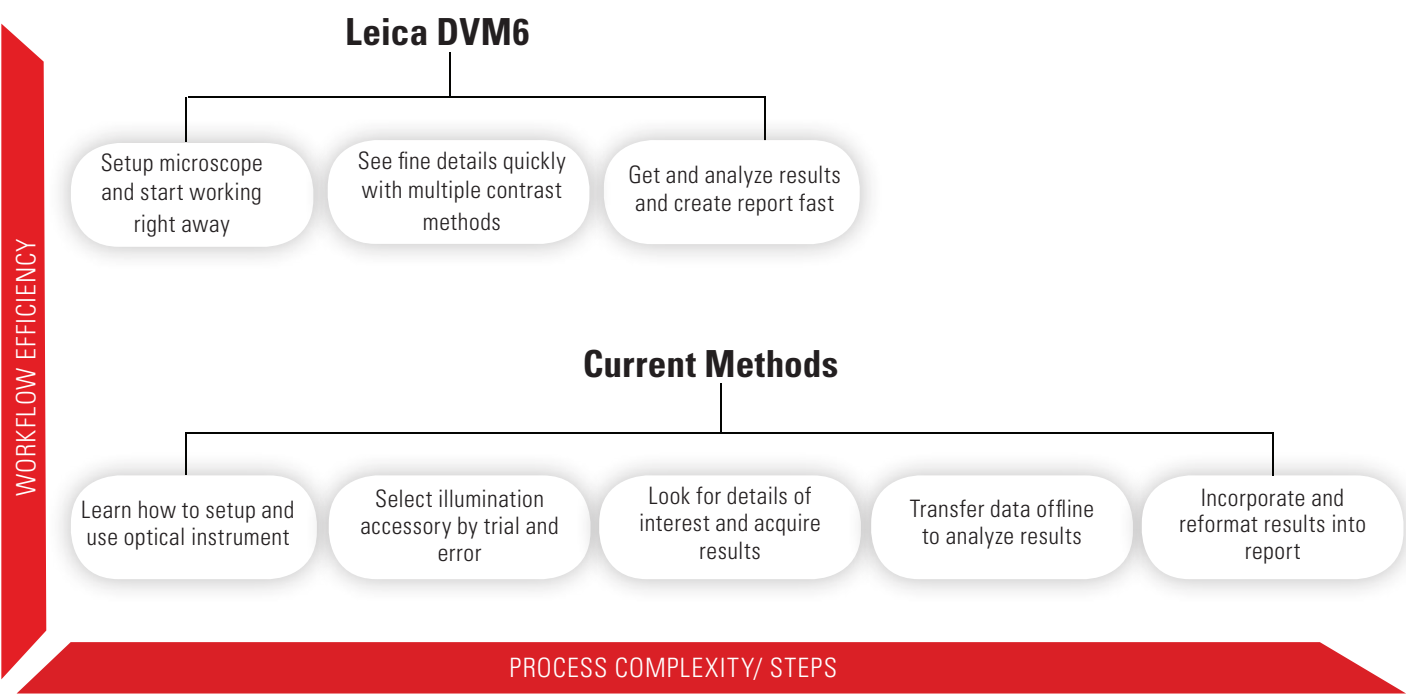
The figure below gives a flow-chart-type description explaining how the Leica DVM6 makes inspection and QC workflow more efficient compared to popular current methods. It shows increasing workflow efficiency is inversely proportional to the process complexity and the number of workflow steps.

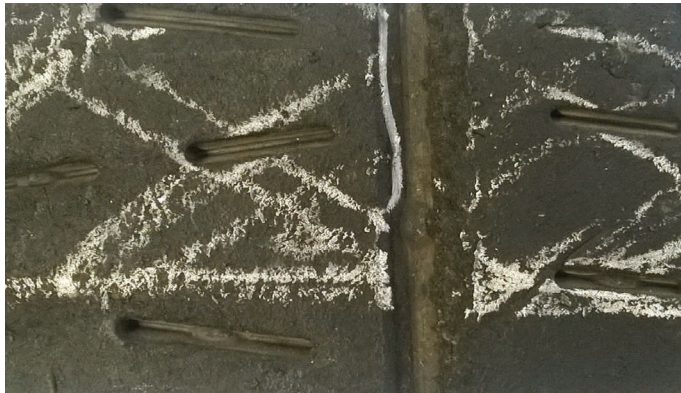
Tread surface of the automobile tire sample

Below are photos of the tread surface and cross section of the automobile tire sample, the top and side view of the air outlet cover sample, and the Leica DVM6 digital microscope with the air outlet panel placed onto its stage.

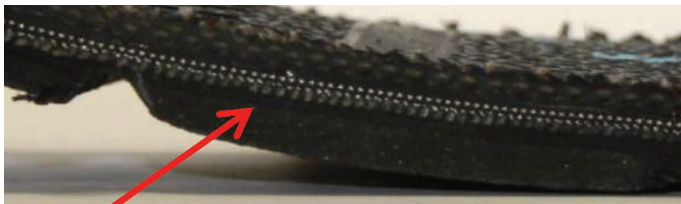
Cross section (red arrow) of the automobile tire sample with inner wall surface above

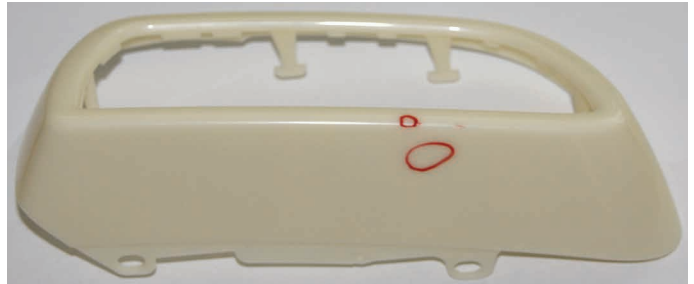
Top view of the car air outlet cover panel

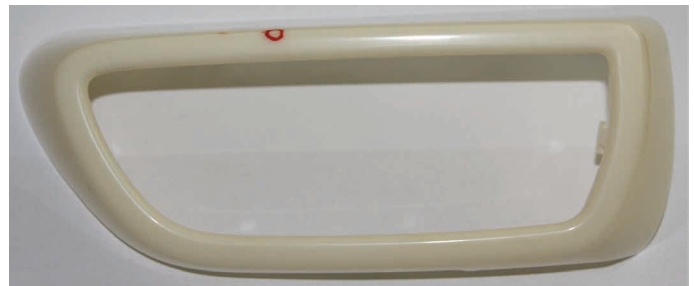
Side view of the air outlet cover panel (red circles mark defects)

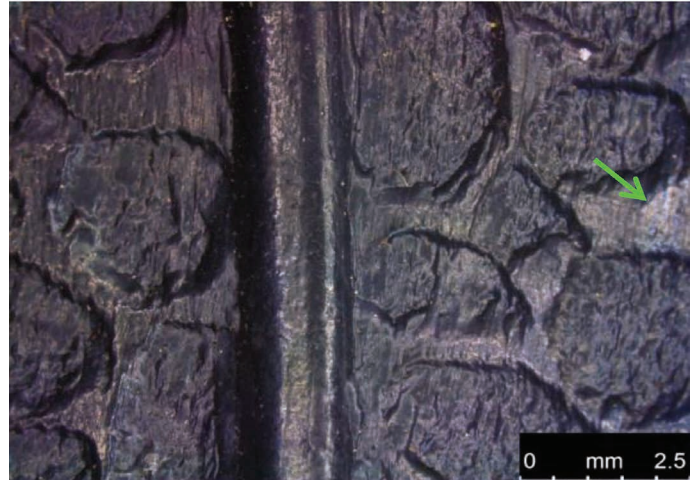
Automobile tire, tilt angle 15° : more fine details visible on the black rubber surface with tilted view

More accurate information about the sample can be gathered when different viewing perspectives are utilized. The Leica DVM6 microscope head tilts to virtually any angle between $+60^\circ$ and -60° with respect to its neutral vertical position. The sample stage rotates between $+180^\circ$ and -180° in a continuous manner over the entire range. Some examples of the tire and air outlet panel samples studied at different tilt angles are shown below. The tilting axis is eucentric, i.e., aligned to the sample focal plane, so as long as the sample is in focus beforehand, it stays in focus when tilted to any angle. Images of the inner wall surface of an automobile tire and the outer surface of a car air outlet panel recorded with the Leica DVM6 having the following microscope head tilt angles are shown below:

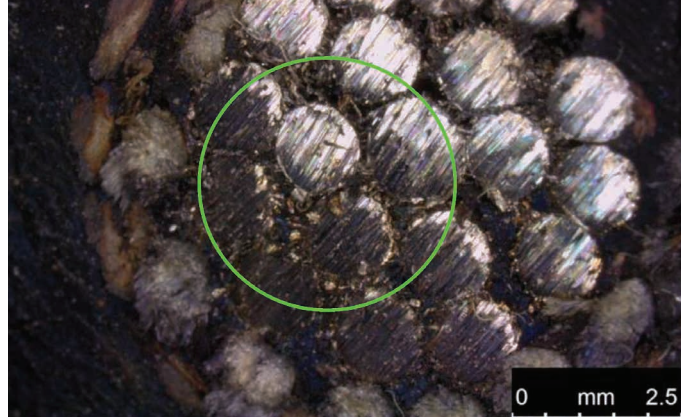
Full ring light illumination of automobile tire cross section: center features highlighted due to back reflection

The image preview mode allows users to see the effect of different lighting, contrast, etc. on the acquired images in a more efficient manner. Images of the metal wires, non-metal threads, and rubber seen in the cross section of an automobile tire and an area of a plastic car air outlet panel showing a defect are shown below. The images were recorded with the Leica DVM6 using the integrated illumination in the modes indicated below:

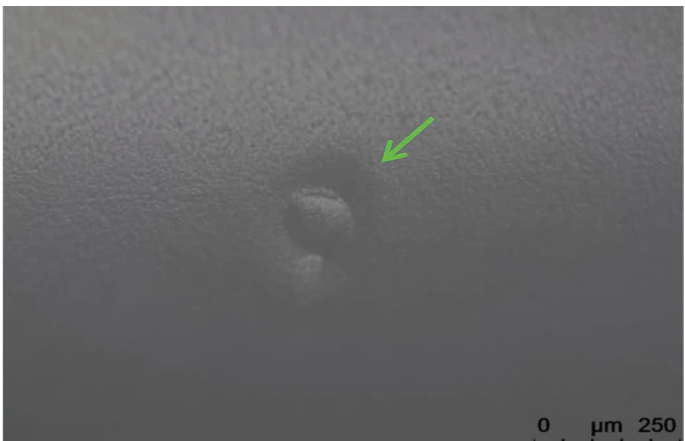
Quarter ring light illumination of the same air outlet panel shown above: better contrast for surface flaws

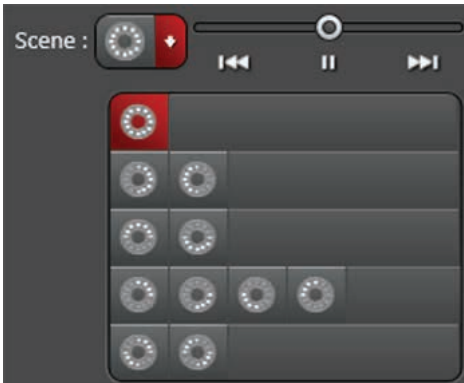
Leica LAS X software scene selection full and quarter ring light illumination

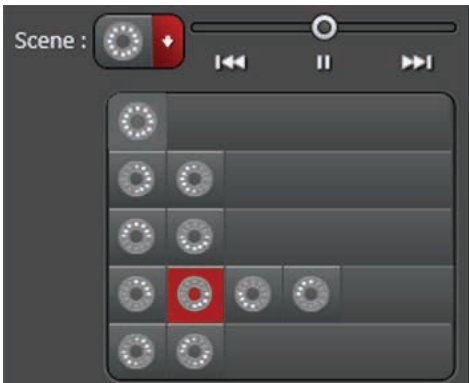
Leica LAS X image previews: 6 images of tire cross section and air outlet panel (small defect) with different types of lighting, contrast, etc.

In Live mode using the Image Preview function, LAS X can automatically acquire six different images using some preset lighting scenarios, e.g., illumination type, light intensity, exposure time, contrast, HDR imaging, etc. You can then decide which of the six images best suits the current sample and use it as the starting point for your image acquisition. You can either use a preset as is, or fine-tune it to optimize the image displayed in Live mode.
